From:
Sent: Wednesday, September 18, 2013 1:32 PM
To: Clark, Richard; Silver, Wendy
Subject: pictures
Attachments: 2013.09.16 036.jpg; 2013.09.16 037.jpg; 2013.09.16 038.jpg; 2013.09.16 041.jpg; 2013.09.16 042.jpg; 2013.04.06 025.jpg

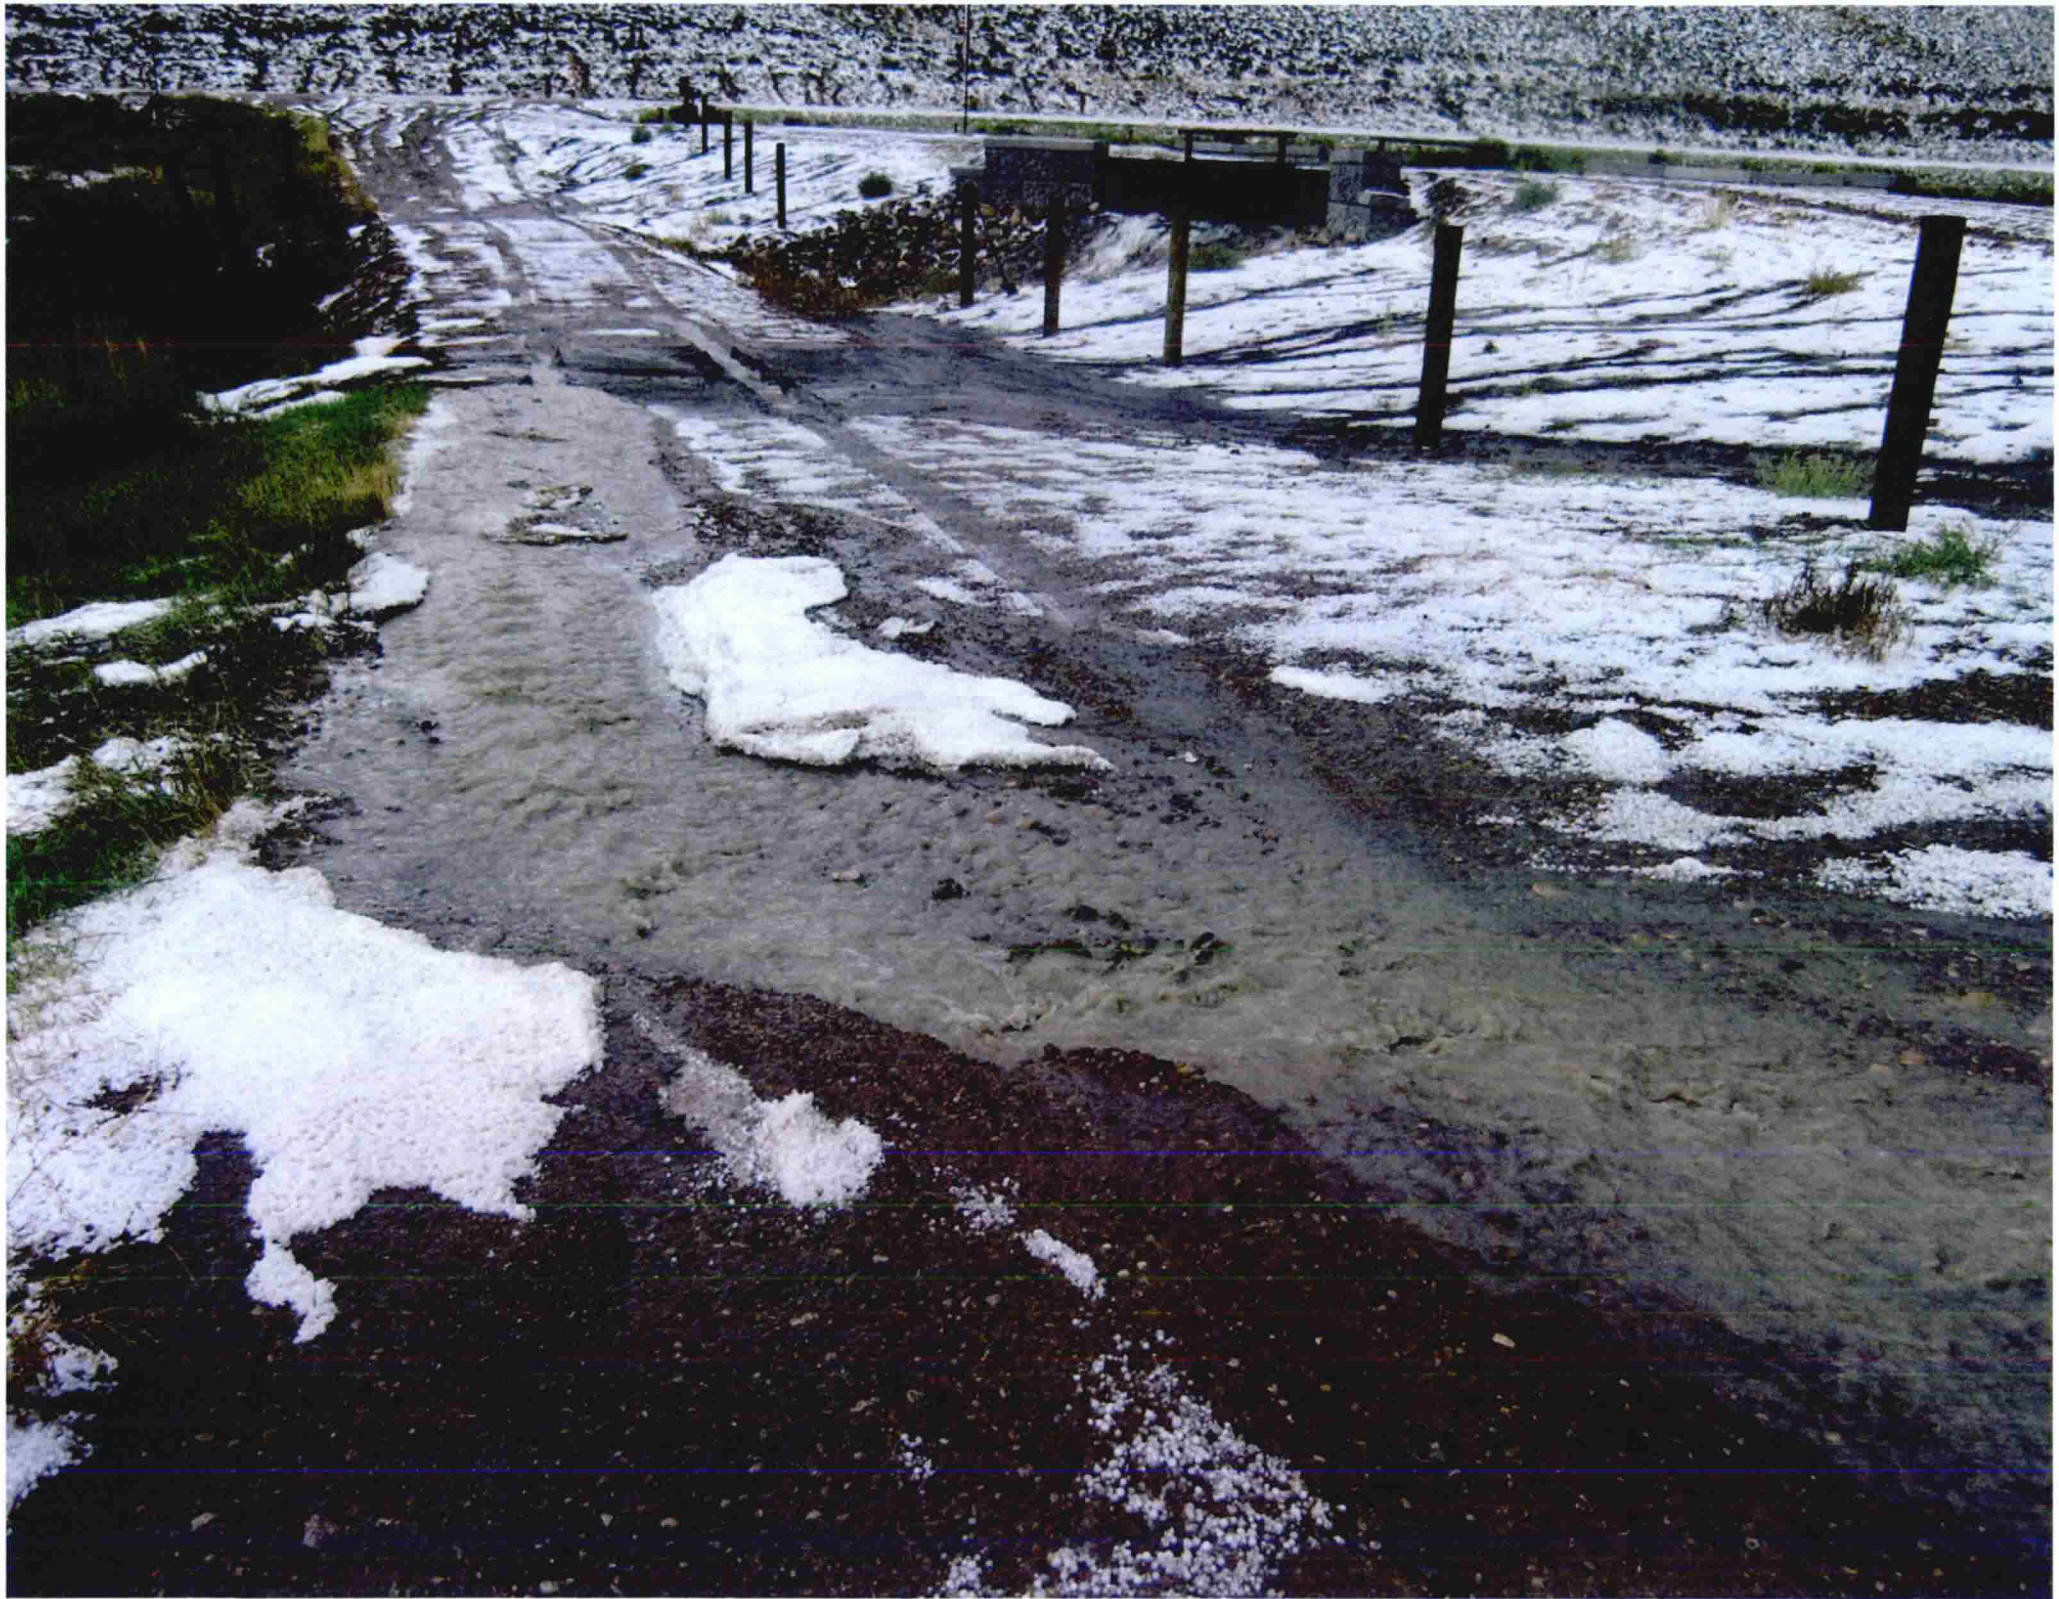
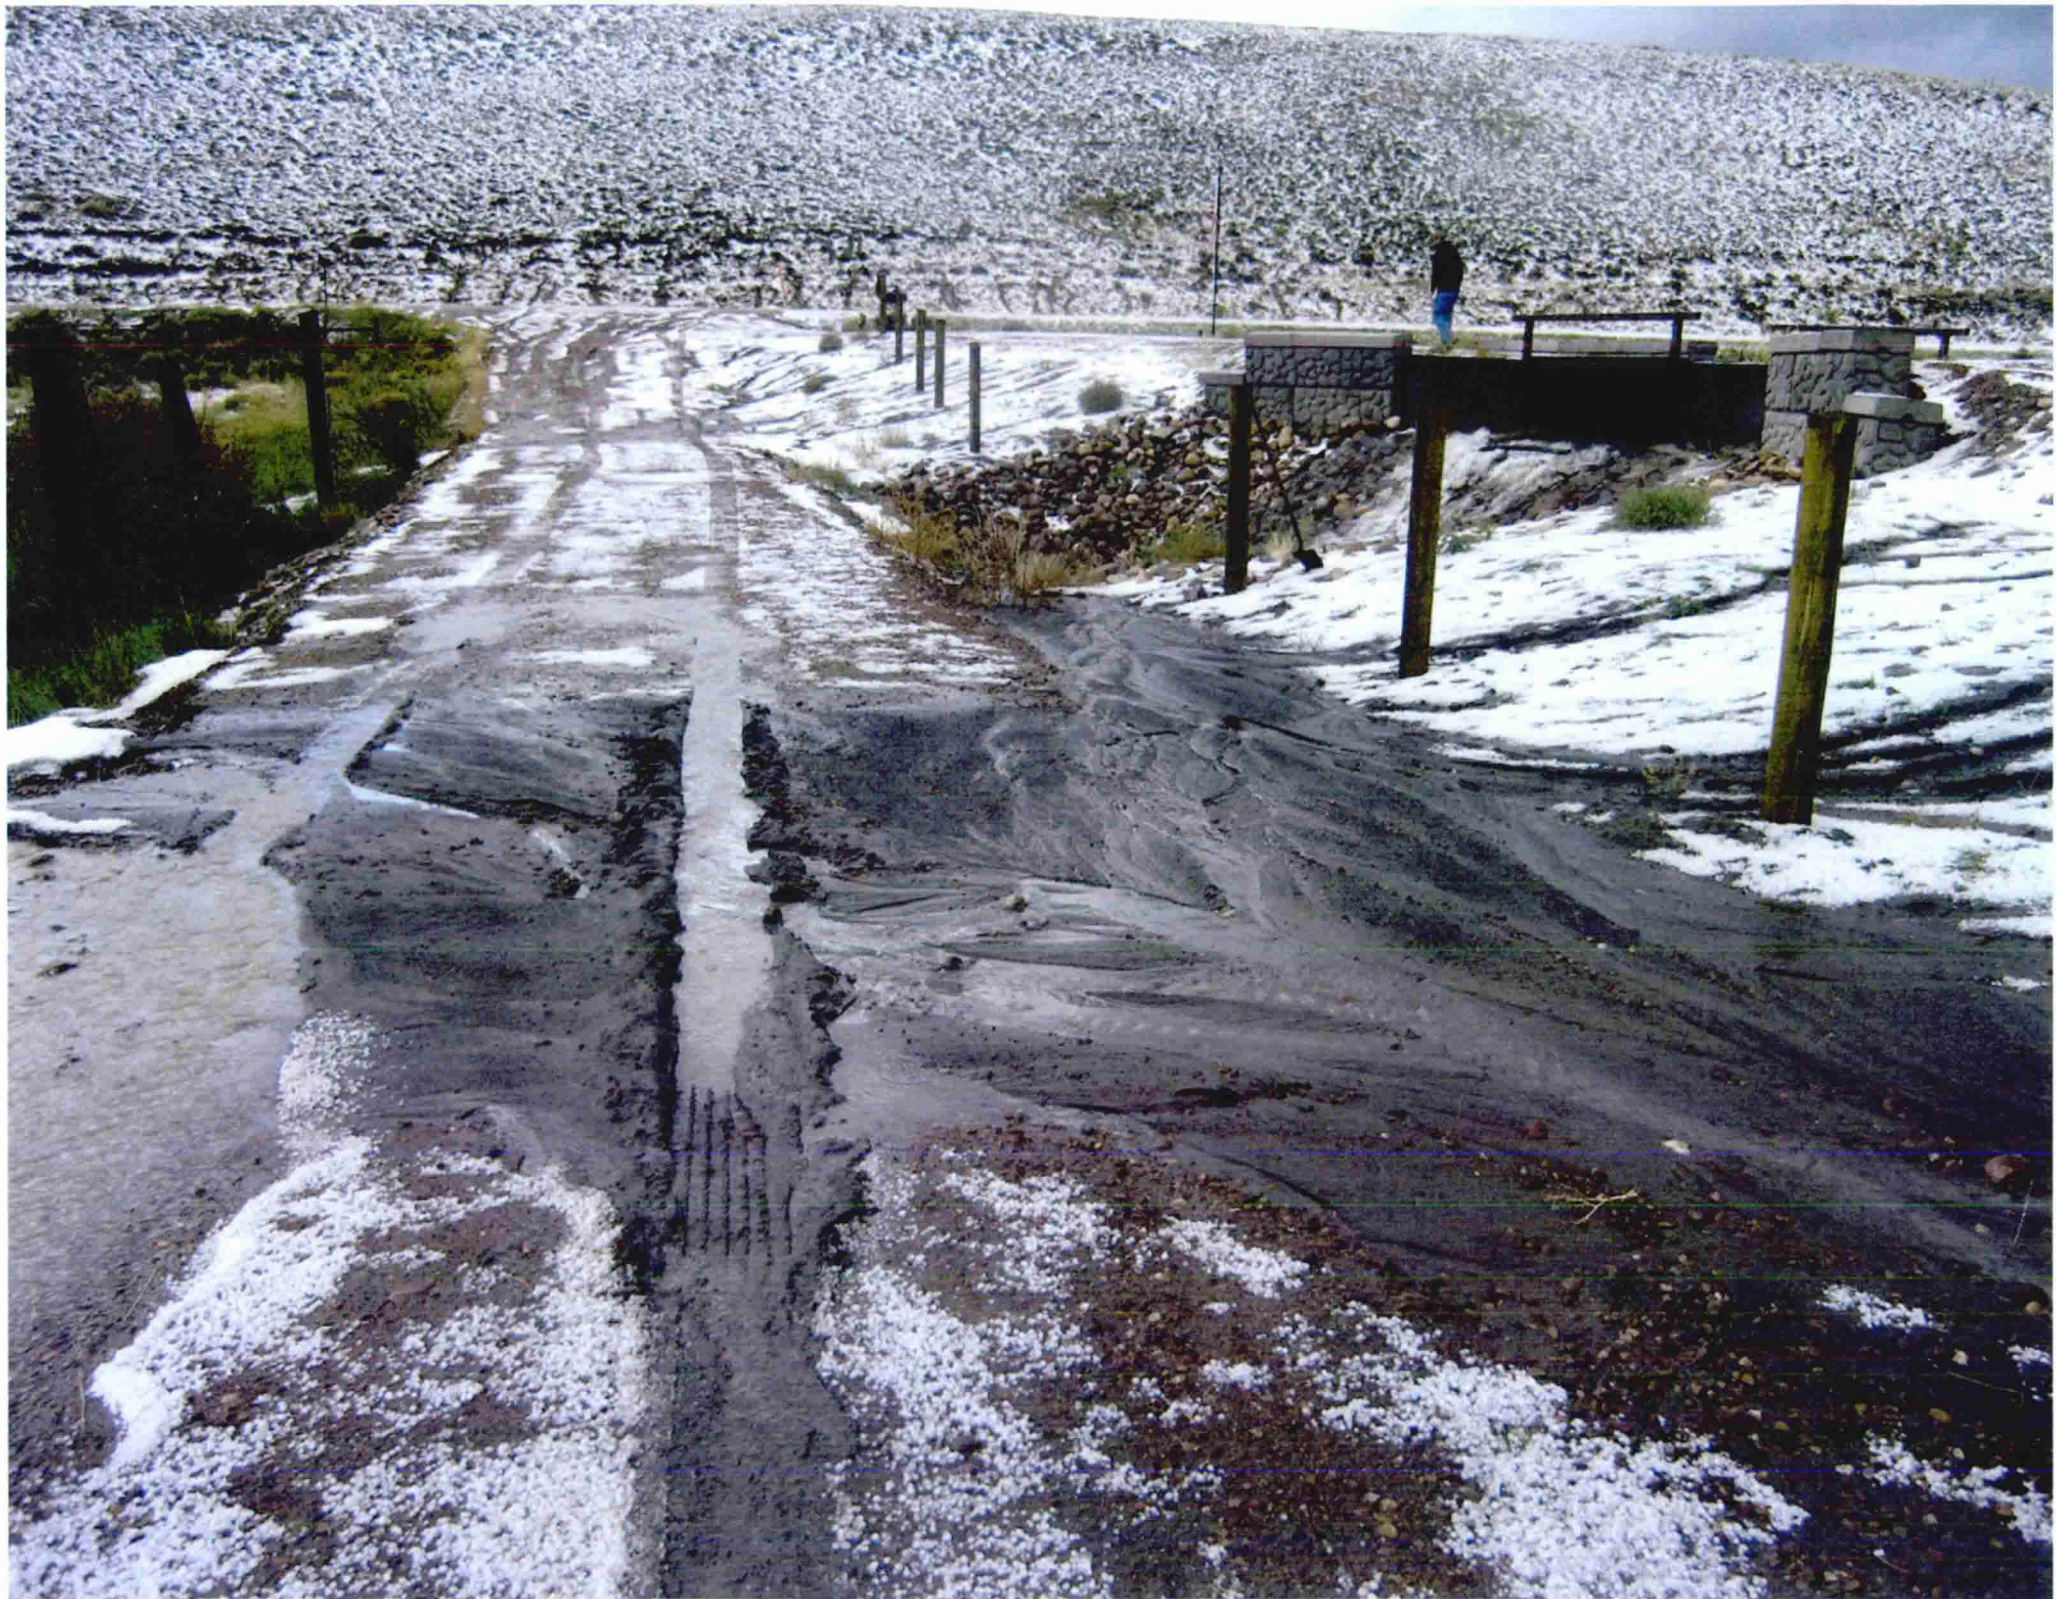
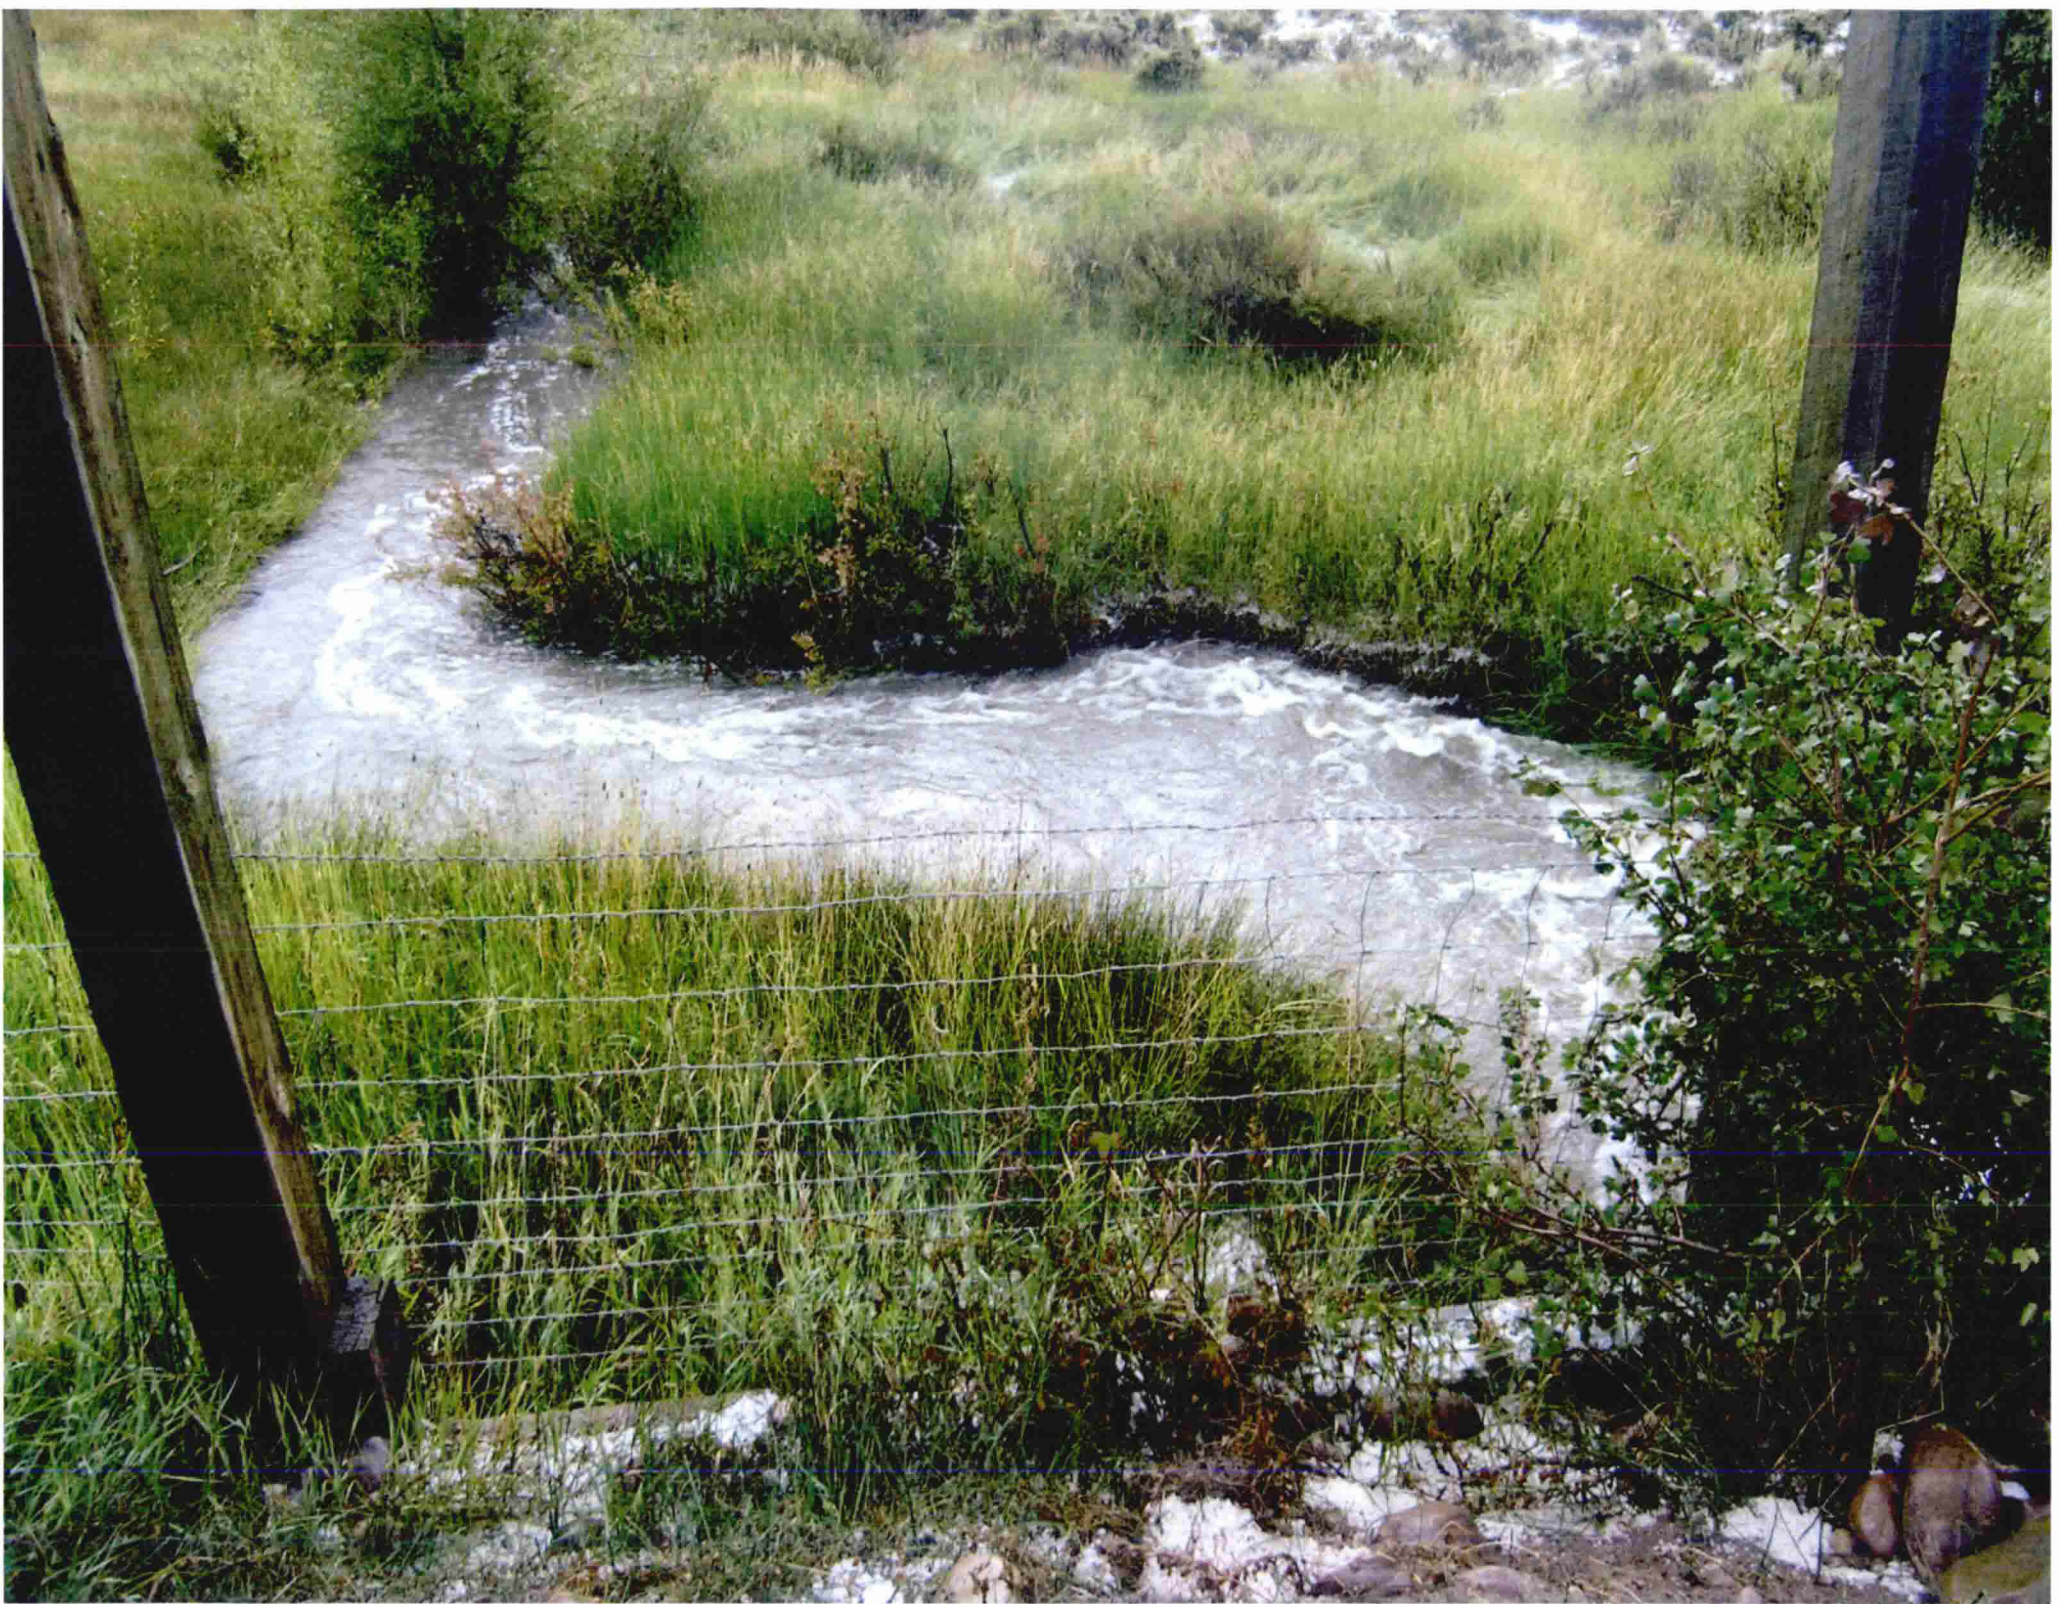
#36, #37 and #42 sediment coming onto driveway

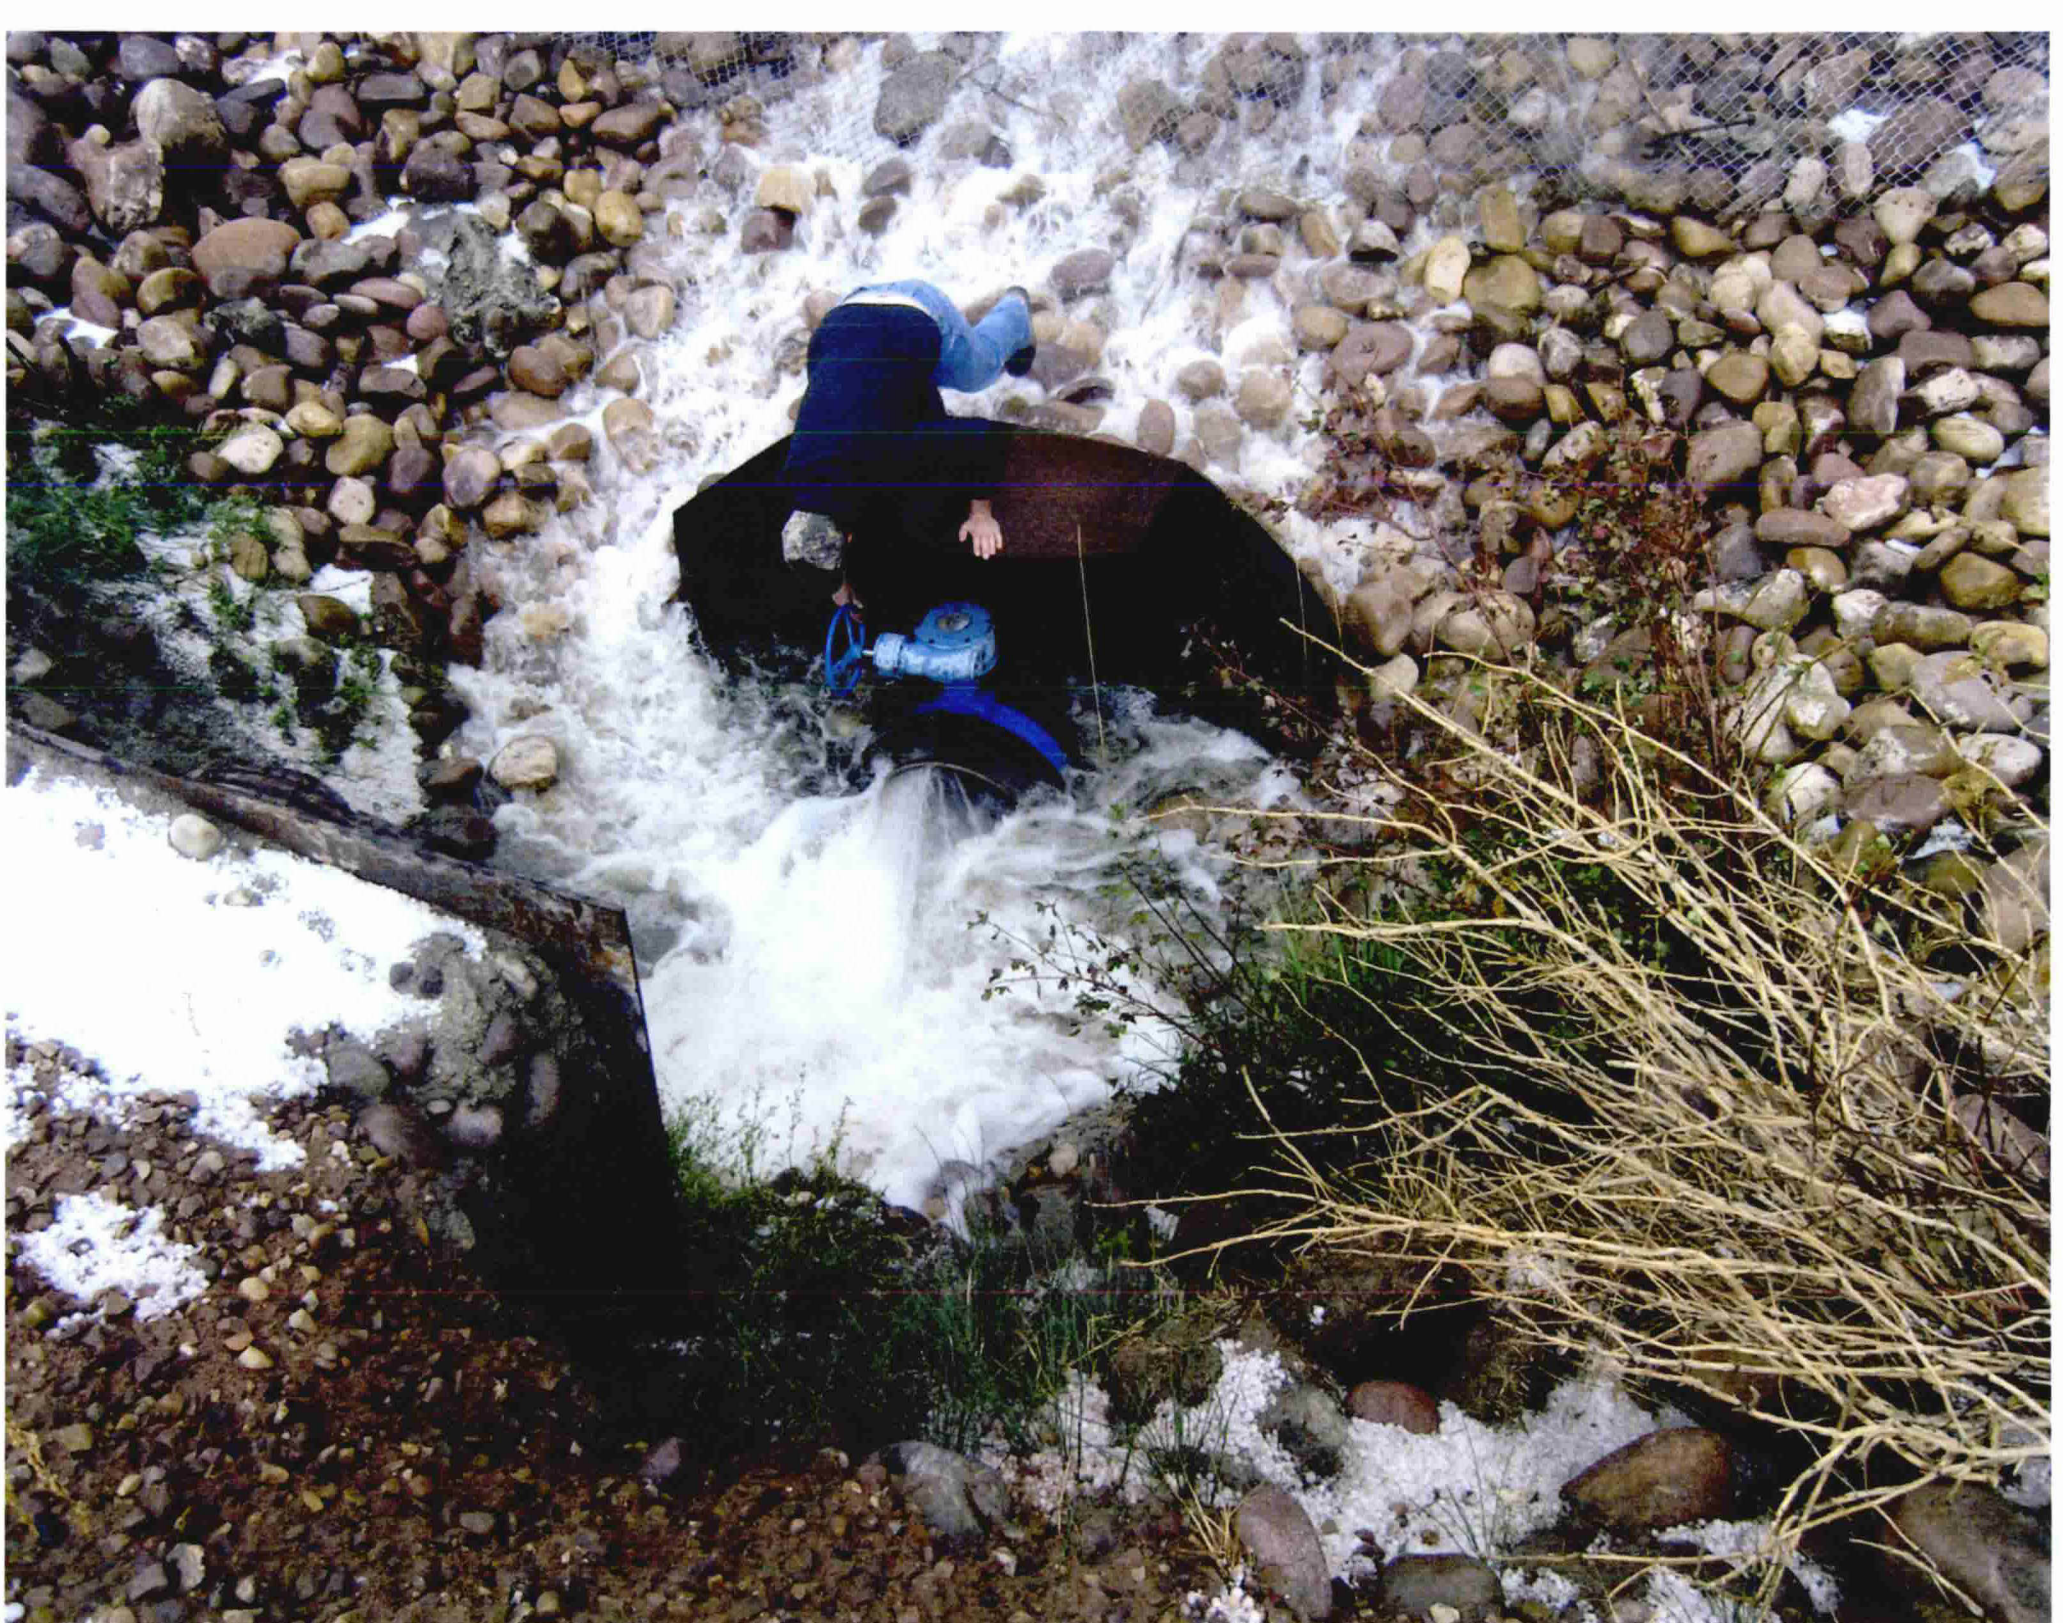
(#41) shows creek full.

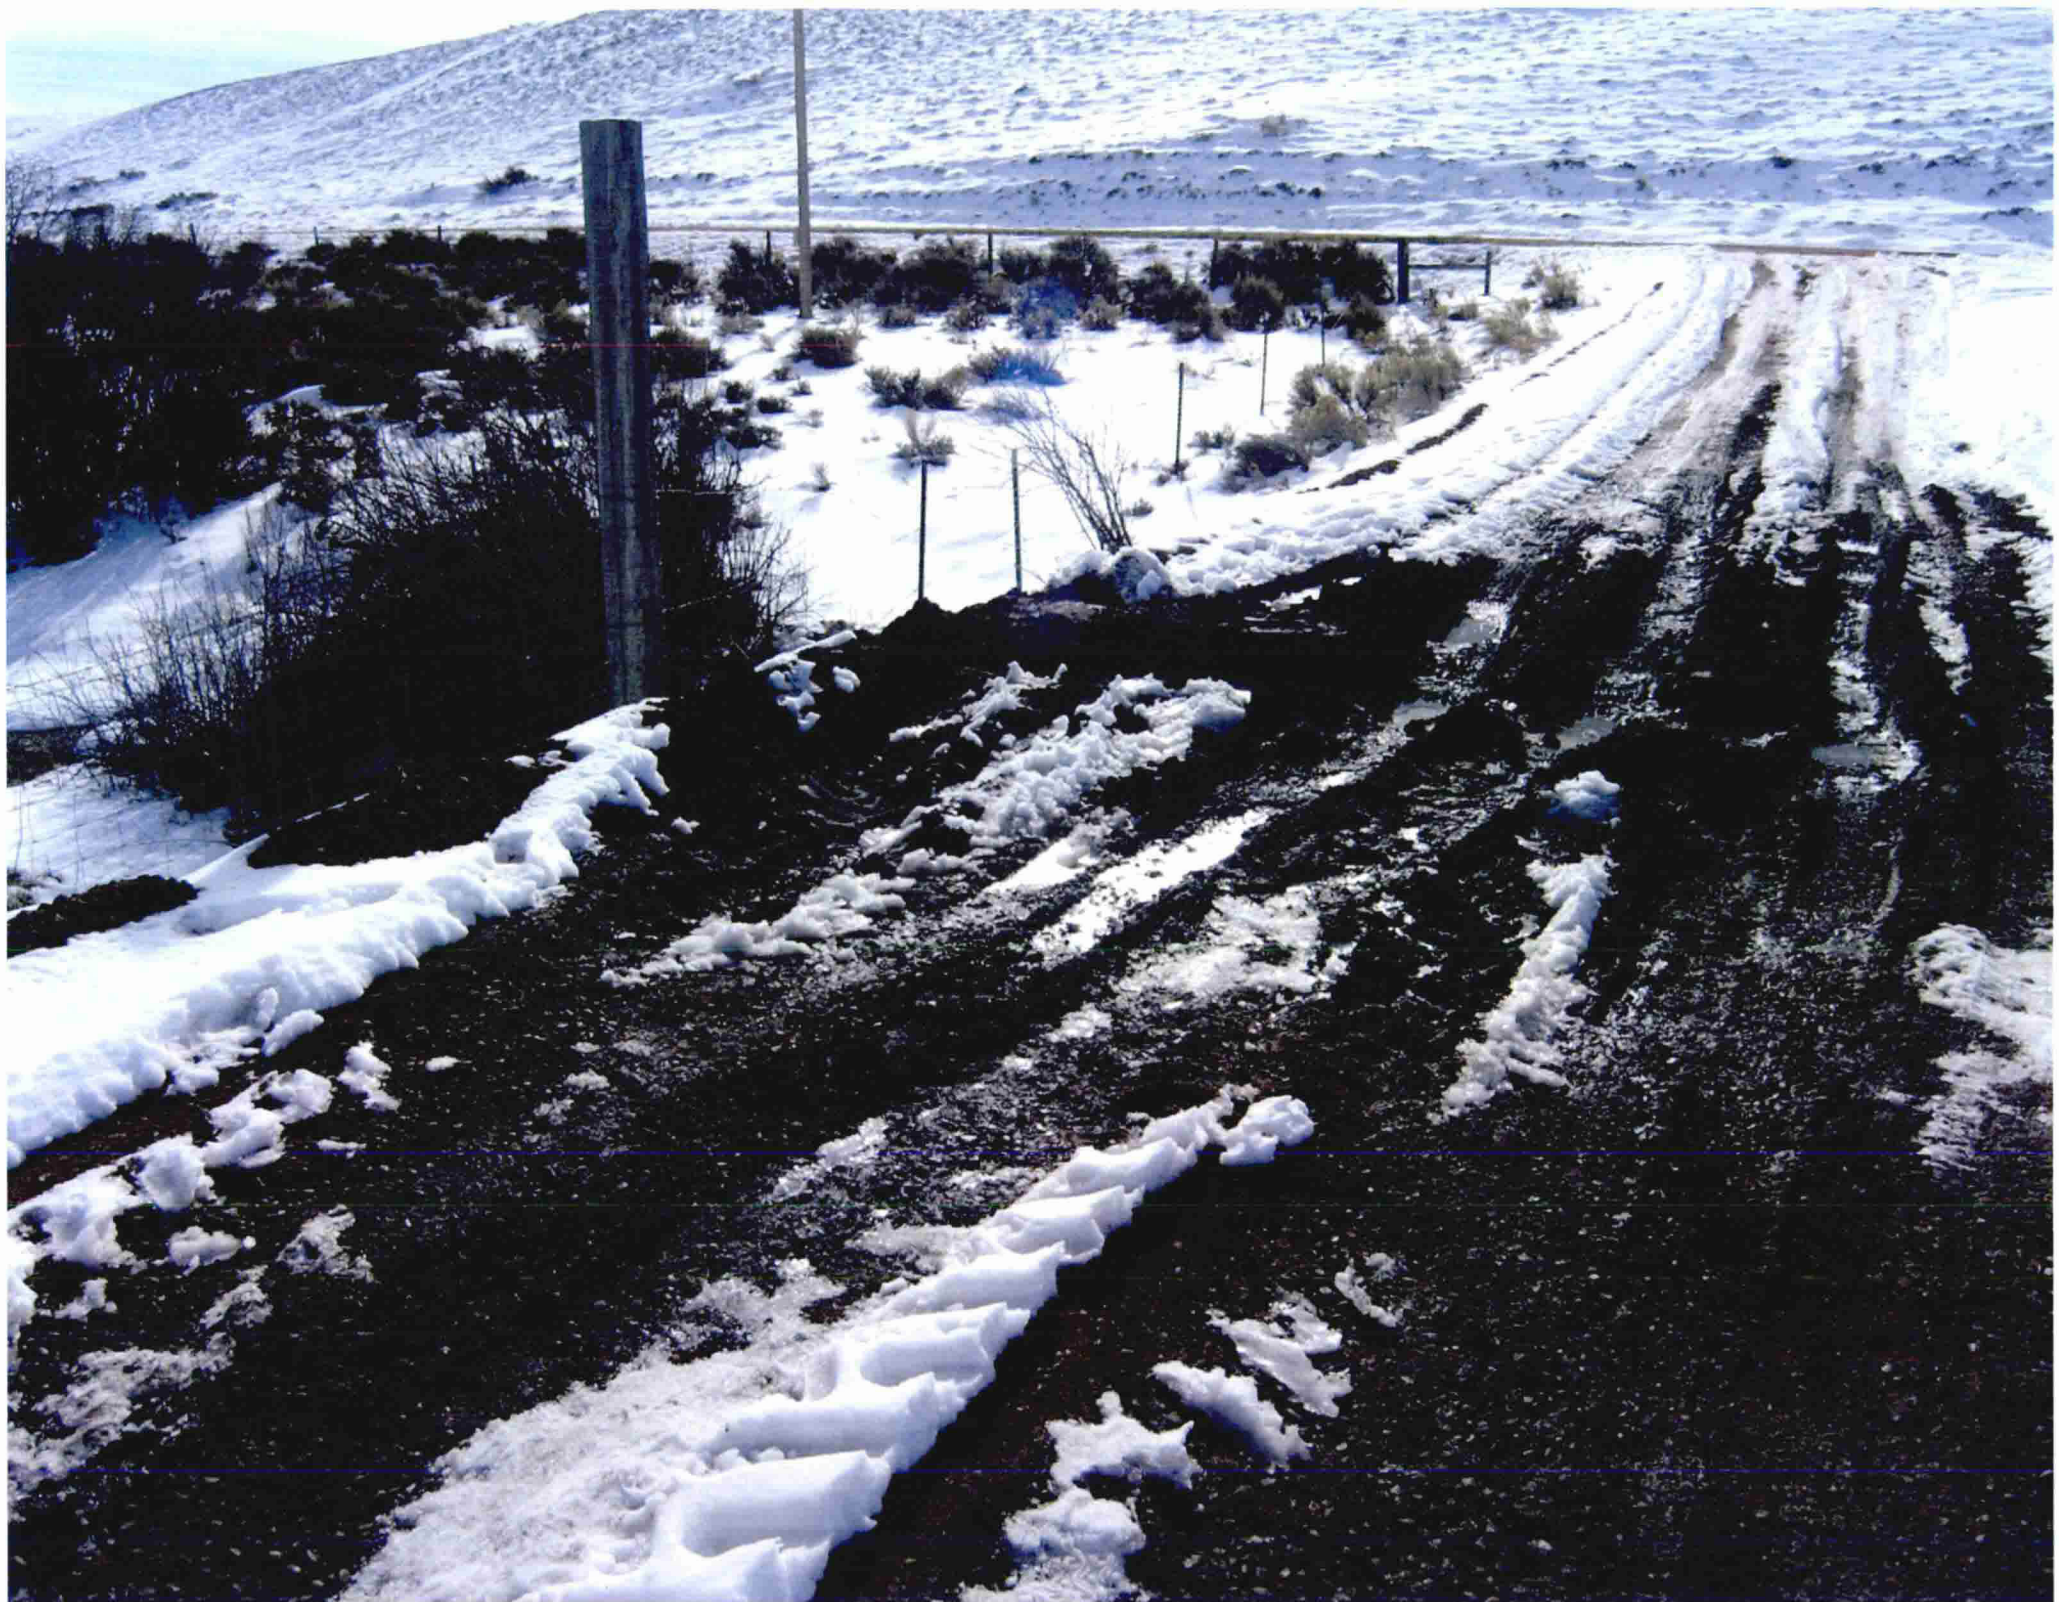
#25 our driveway last spring.
